REPLACEMENT INSTRUCTIONS

Brush Holder Support For TRIAC ST/AT

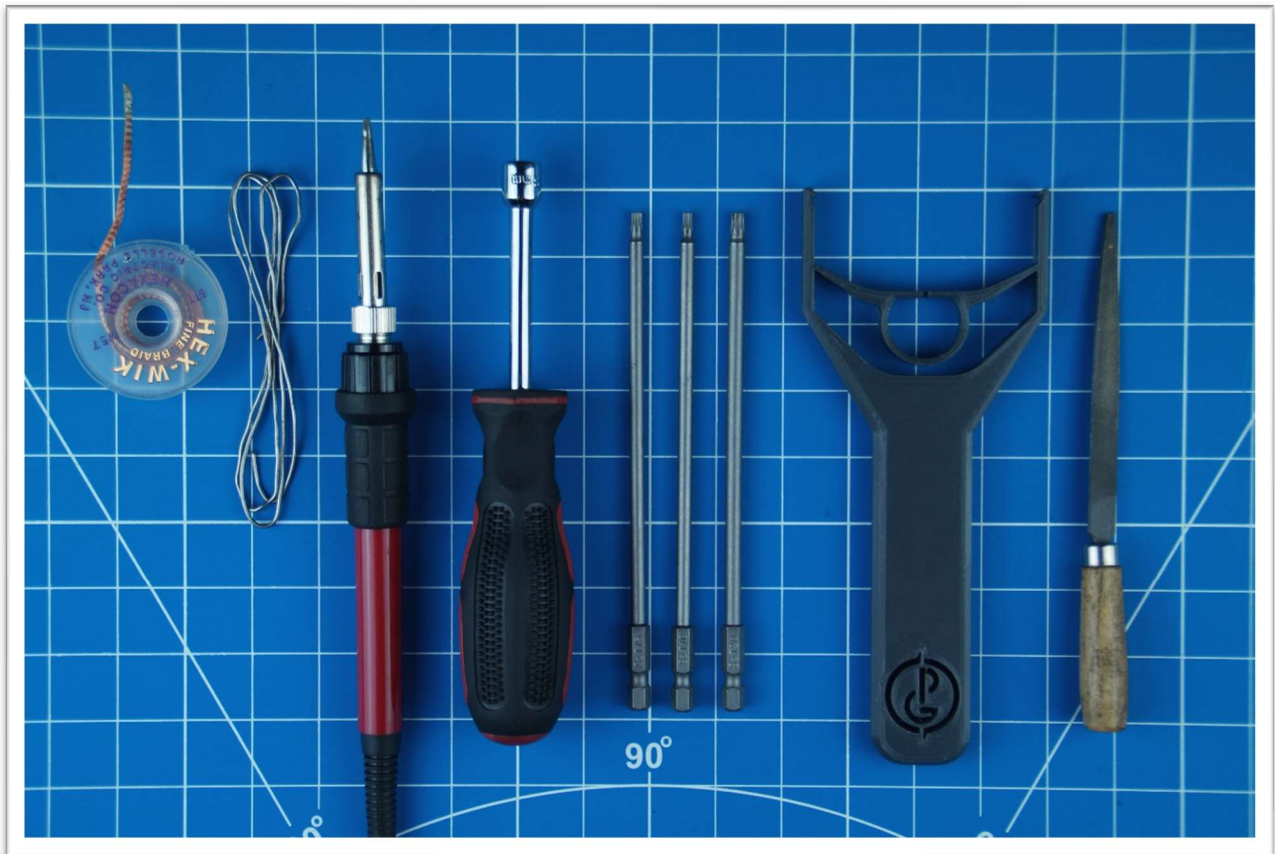
- 8mm socket wrench
- T10 Torx screwdriver
- T15 Torx screwdriver
- T20 Torx screwdriver
- Soldering iron
- Solder

- Small file, sandpaper, or benchtop grinder
- Impeller removing tool (or two screw drivers – not recommended)
- Steel wire brush
- Nose pliers

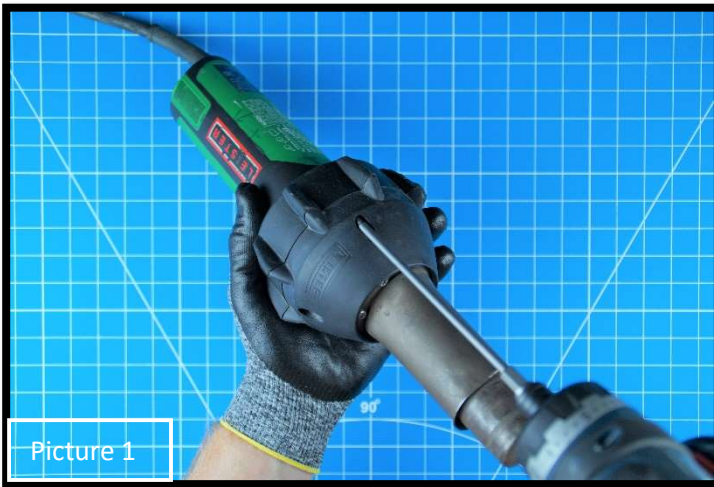
Loosen the four screws using T15 Torx screwdriver

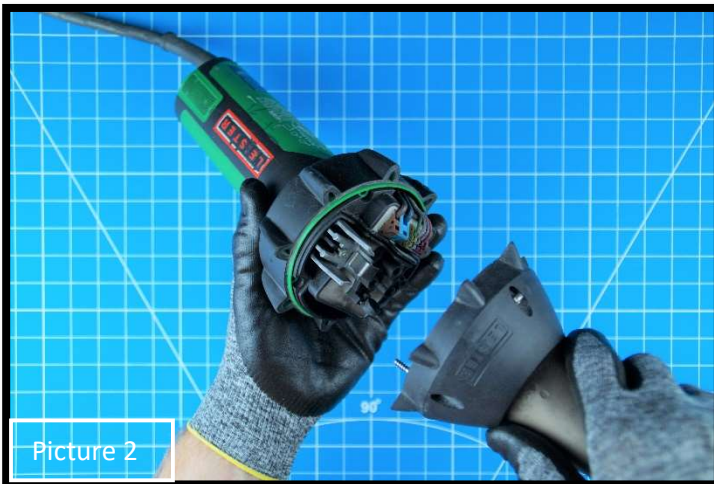
Gently but firmly pull out the top part of the housing.

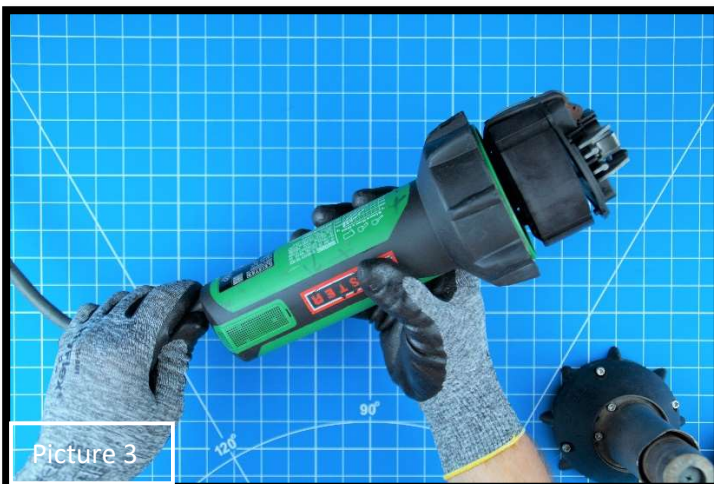
By pressing in the power cord push out the motor from the bottom part of the housing.

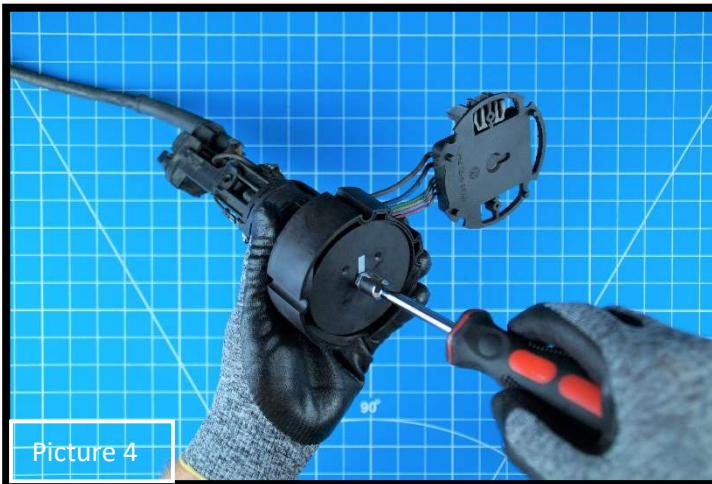
Using 8mm socket wrench loosen and remove the nut.

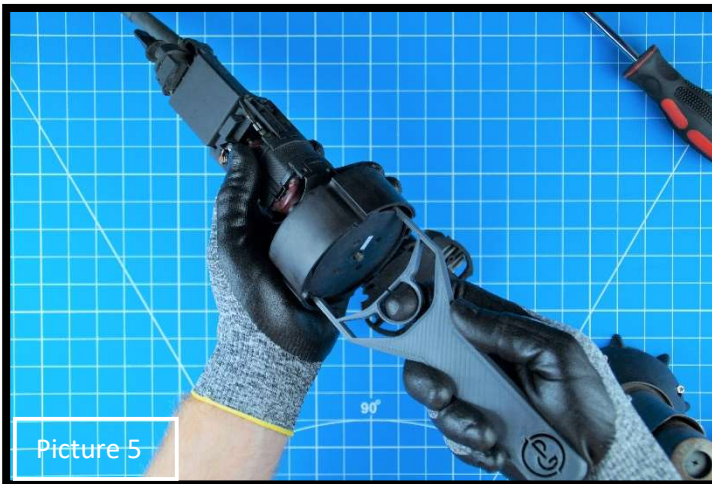
Using impeller extraction tool remove the top impeller.

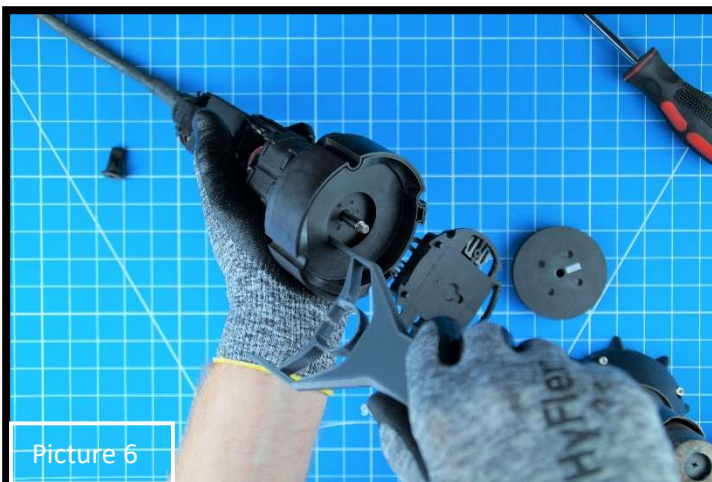
Using one leg of the extraction tool remove impeller separator.

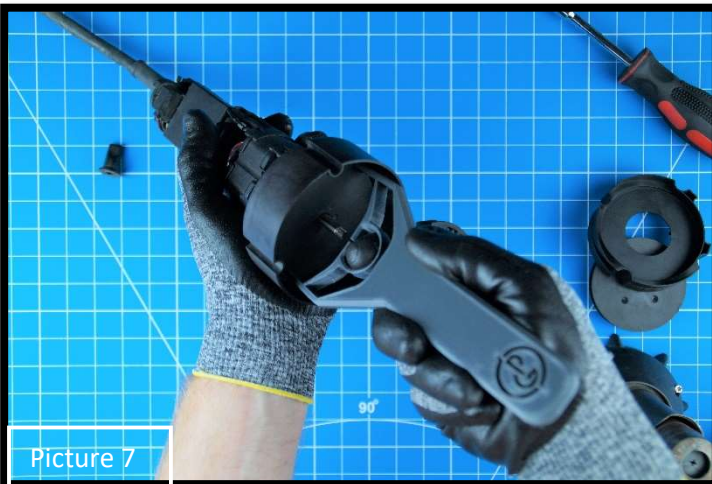
Remove bottom impeller in the exact same way as the top one (Picture 5).

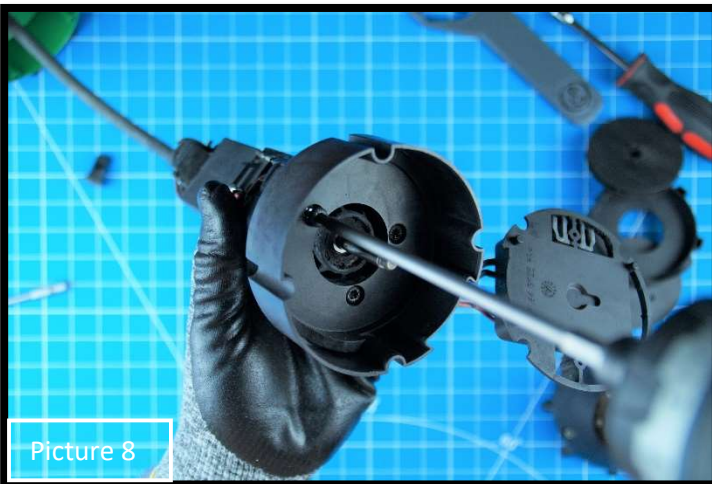
Loosen and remove three screws using T20 Torx screwdriver.

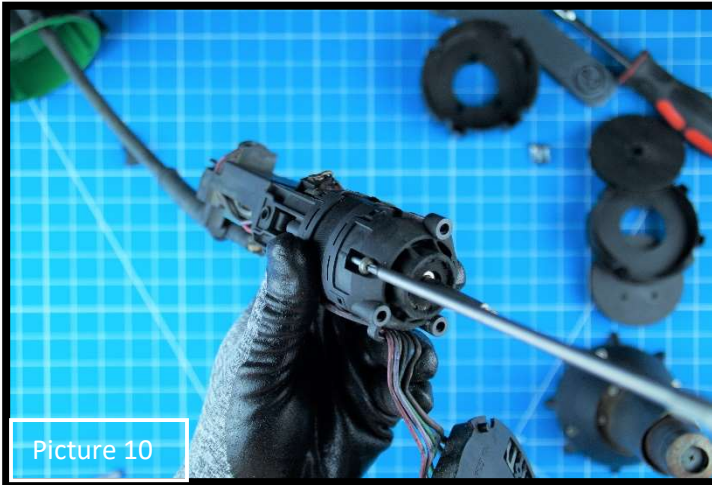
Using T10 Torx screwdriver remove two screws that holds the motor assembly together.

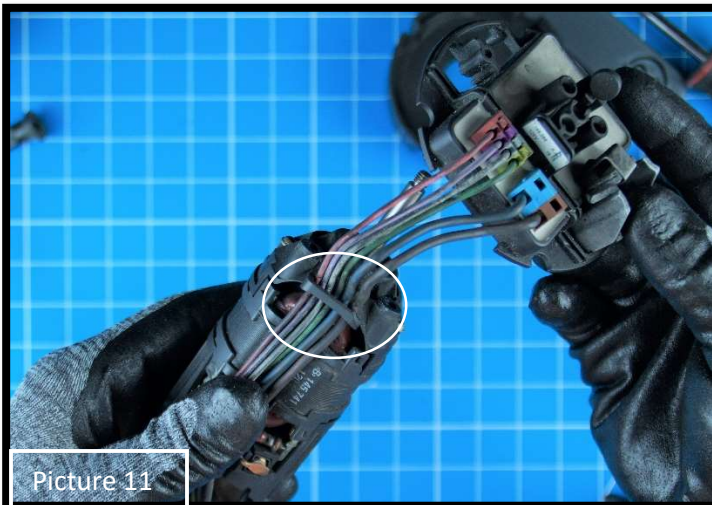
Remove the wire from the top bracket.

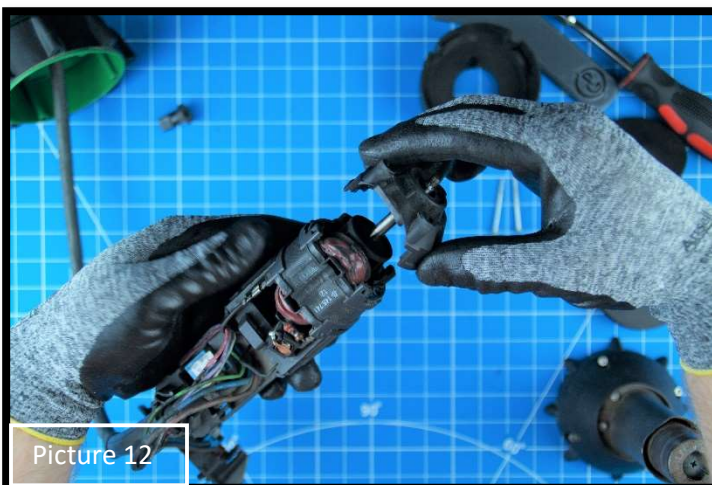
Remove top rotor support.

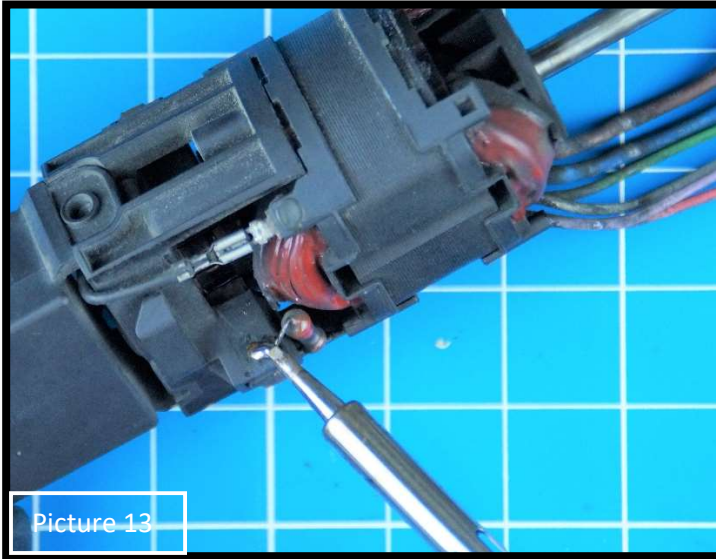
Remove the solder from the tab of both brush holders. Best practise is to use a wick wire.

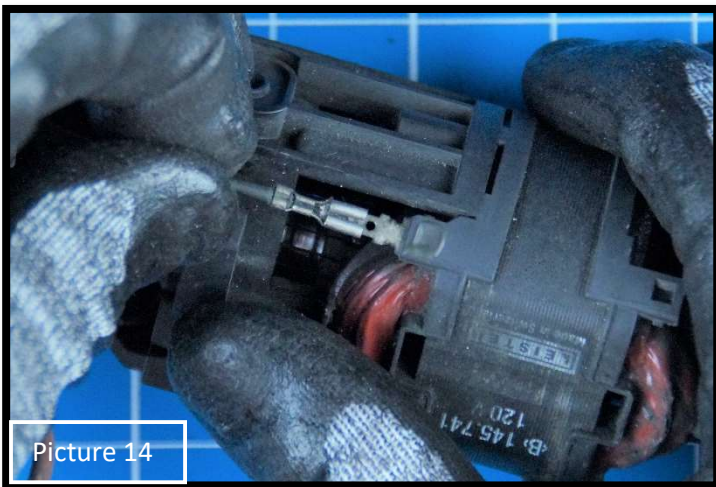
Disconnect both of the motor power cables.

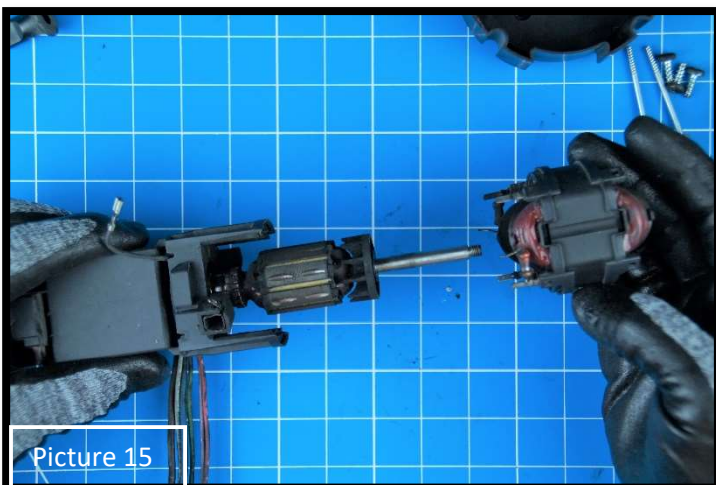
Remove the stator assembly.

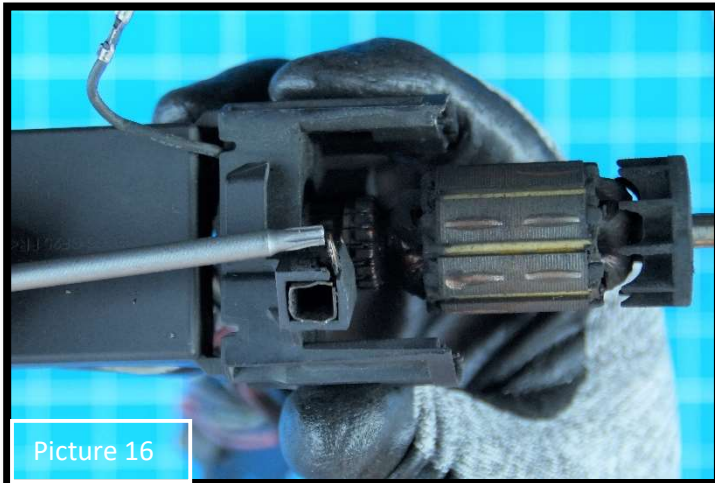
Before removing, gently lift the brush holder tab. Do this to both brush holders.

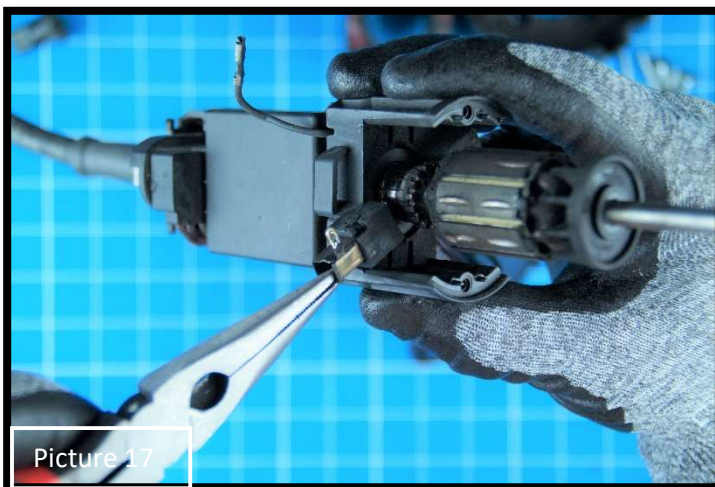
Using nose pliers pull out the brush holders from the brush holder support.

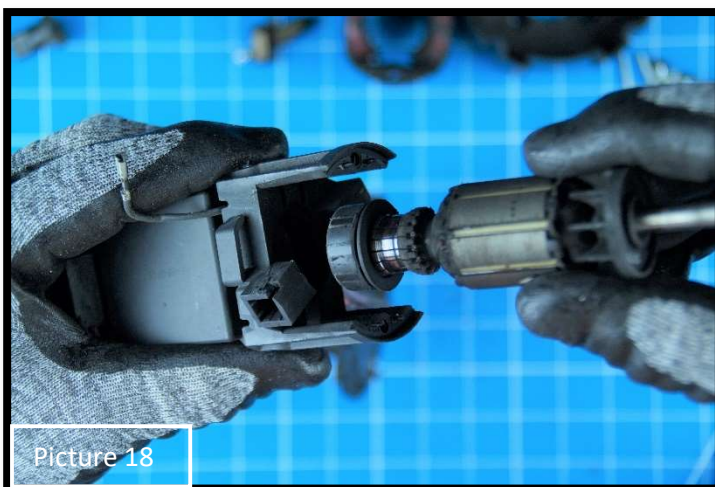
Remove the rotor with its ball bearing.

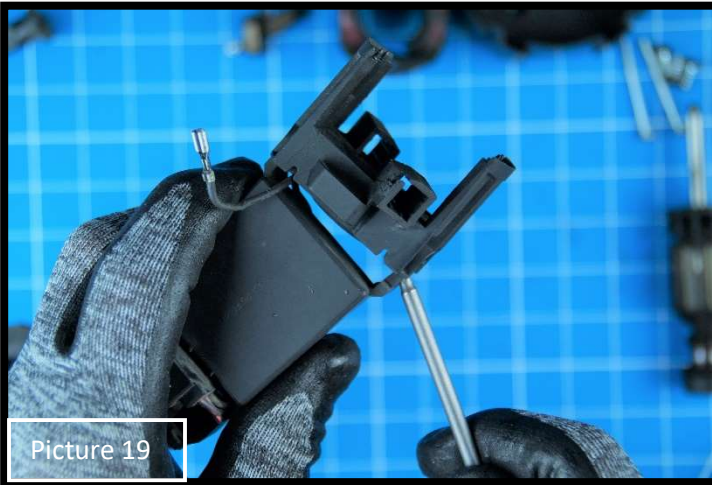
Detach the electronic circuit support which is snapped on the brush holder support. Best practise is to pry it with a pointy tool.

NOTE:
DO NOT USE EXCESSIVE FORCE!

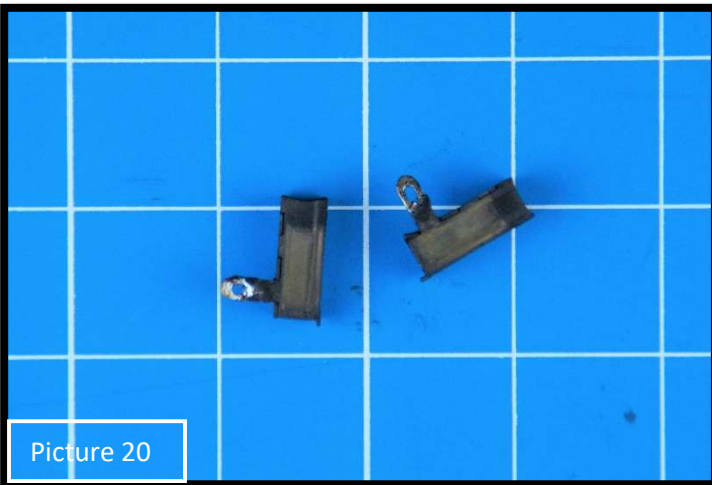
Two otherwise damaged brush holders.

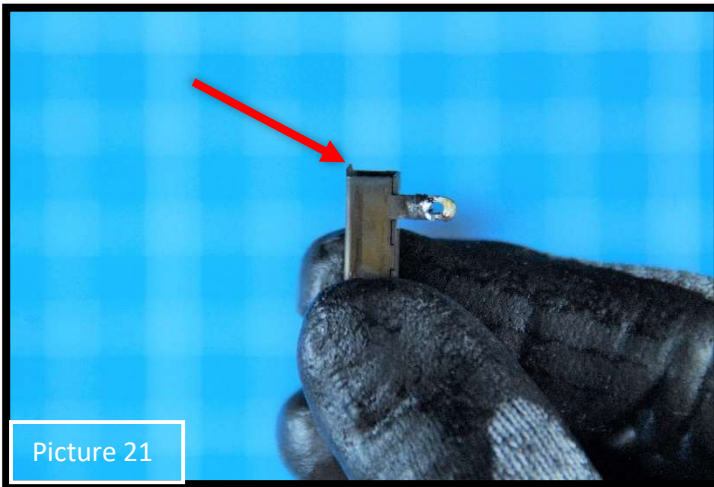
Piece of the brush holder that needs to be modified to fit the new brush holder support.

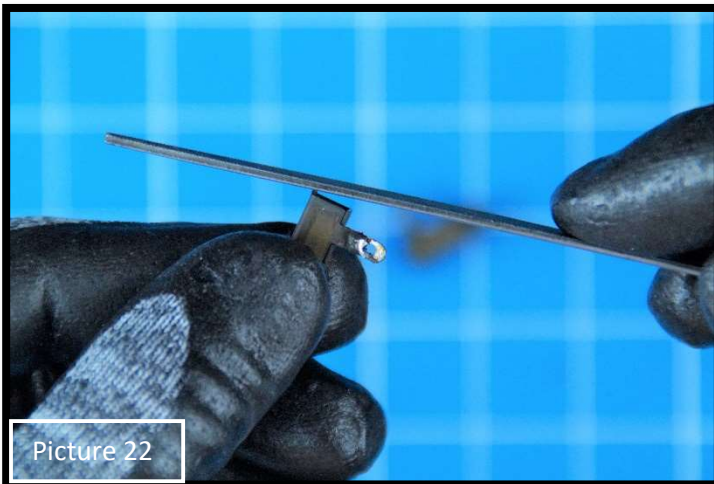
Using a file/sandpaper/table grinder remove the broken piece of the brush holder.

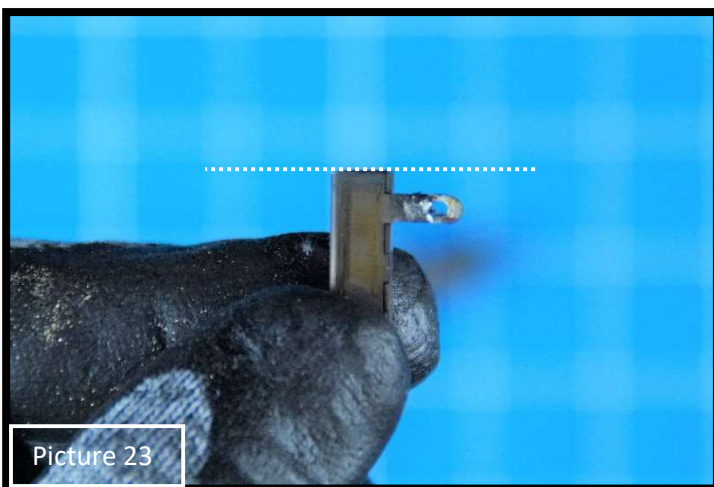
This is how the modified brush holder should look like.

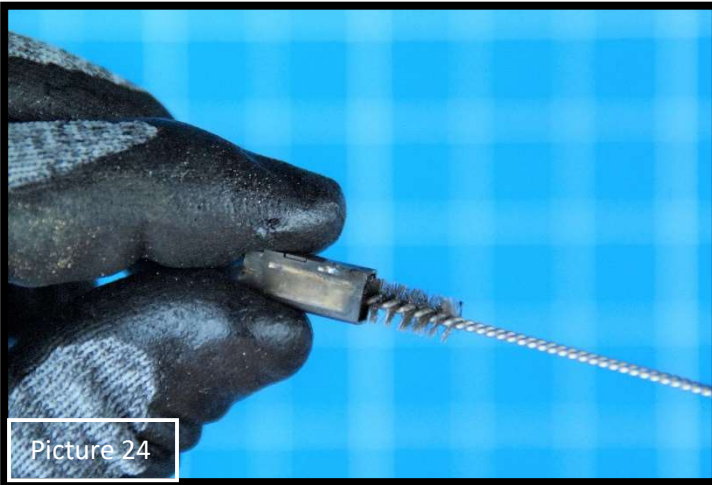
As a good practise clean the inside of the brush holder using steel tube brush.

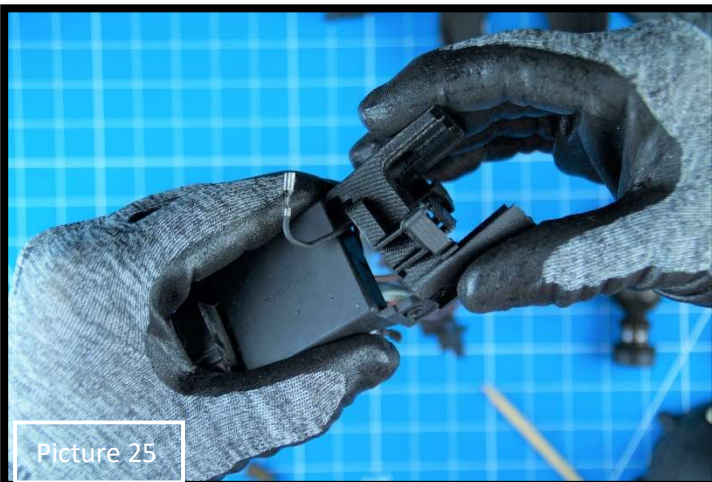
Snap in the new brush holder support.

NOTE:
DO NOT USE EXCESSIVE FORCE. YOU MAY BREAK THE TABS

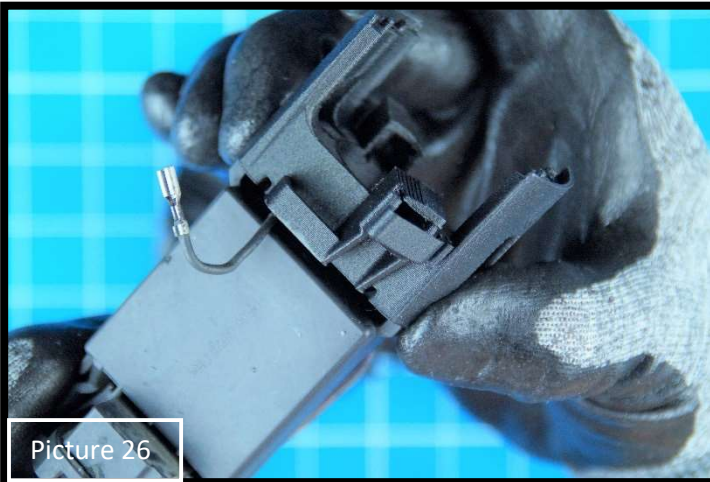
After fitting the brush holder support press on to the tabs to ensure that they are snapped in place.

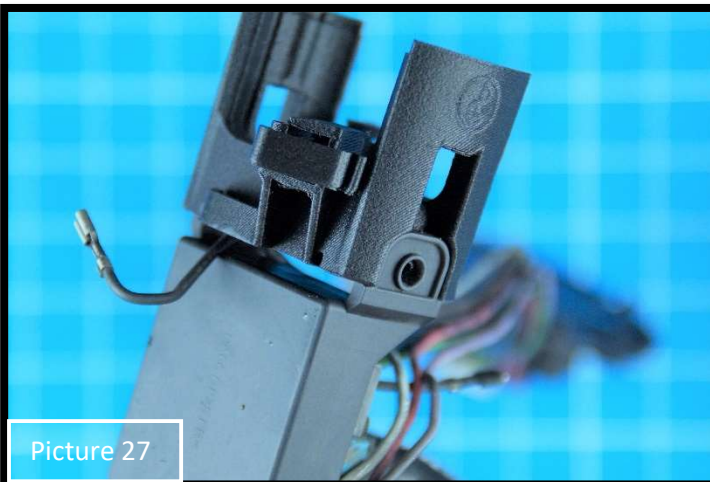
This is how properly fitted brush holder support should look like on both sides.

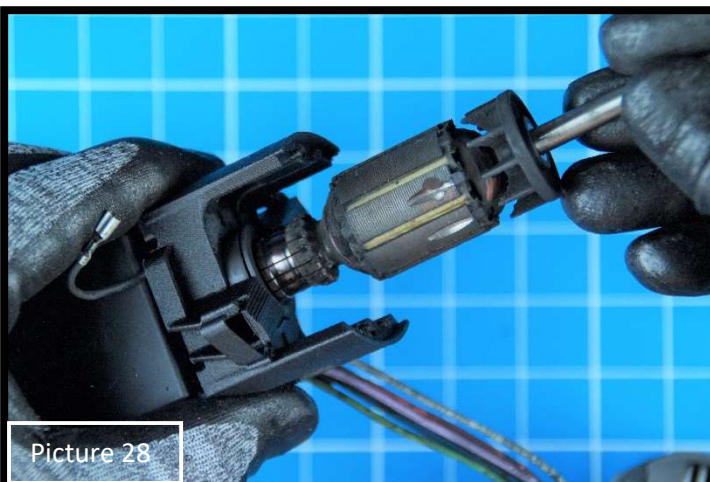
Press in the rotor.

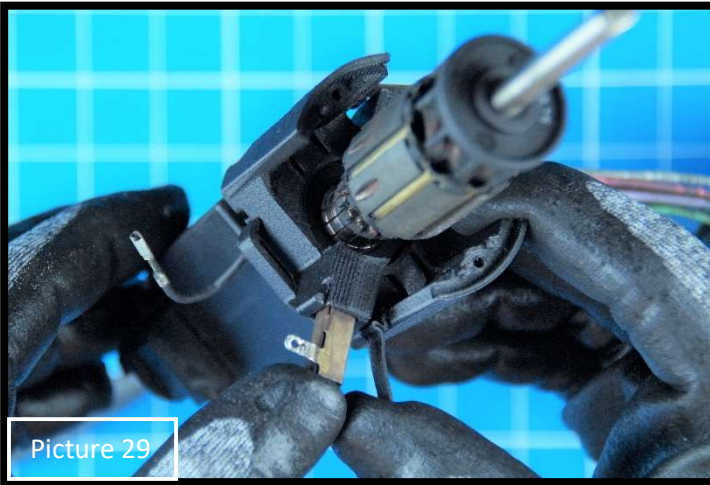
Push in the brush holders to the brush holder support.
Make sure the brush holder is parallel to the opening.

Push the brush holder until it sits flush in the housing.

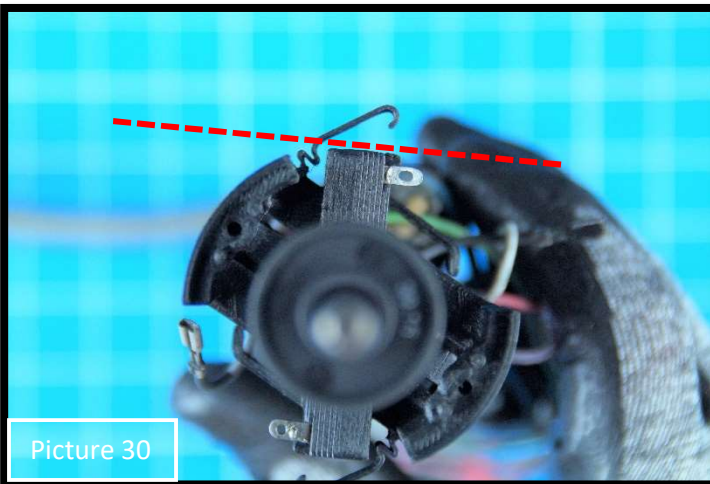
Correctly installed brush holder will sit flush with the face of the housing.

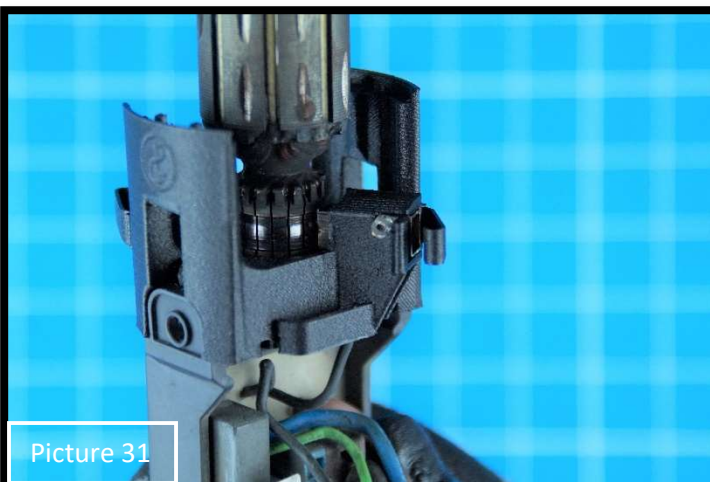
Using nose pliers gently twist the brush holder tab in the clockwise direction about 45 degrees.
Then press it down about a millimetre.

This will keep the brush holder from sliding out of the housing.

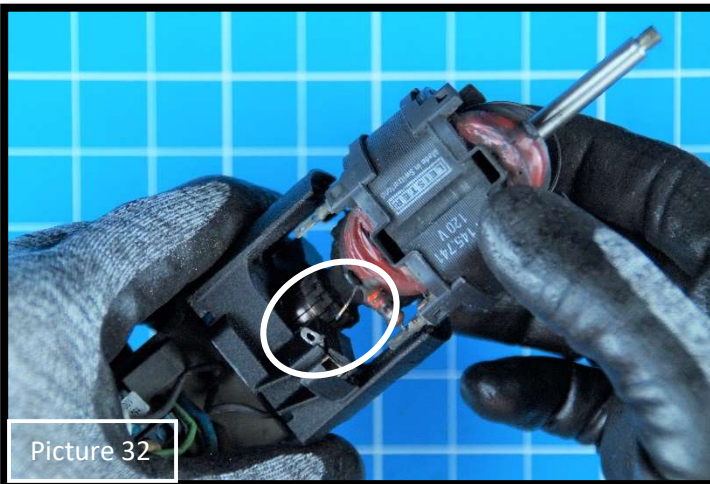
Picture 32

Install the stator assembly.

Make sure the resistor wire fits into the hole of the brush holder tab on both sides.

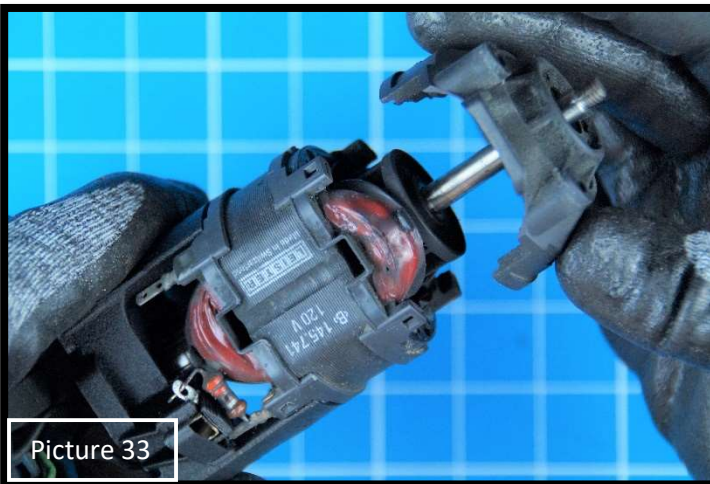
Picture 33

Install the top rotor support.

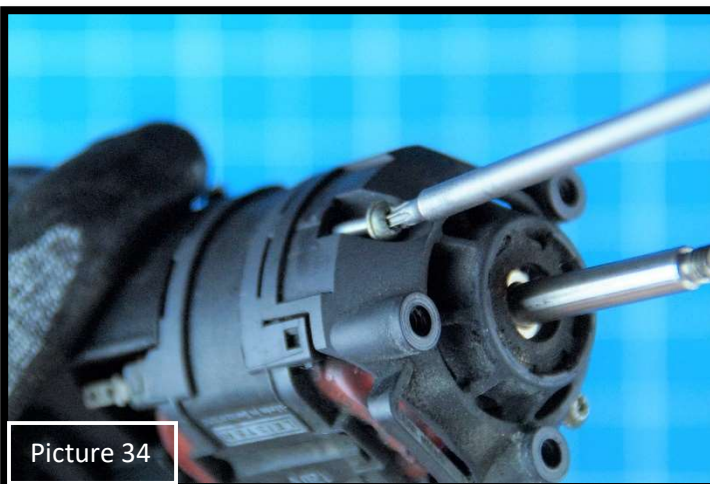
Picture 34

Using T10 Torx screwdriver screw in the two screws that holds the motor assembly.

| Inconsistent speed | <ul style="list-style-type: none"> • 8mm nut is not tight enough – tighten the nut • New carbon brushes are not settled in – give 10-15 minutes for carbon brushes to settle in • Worn out ball bearing • Motor assembly screws (Picture 34) are not fully tightened – tighten the screws |
| Excessive motor power consumption | <ul style="list-style-type: none"> • New carbon brushes are too tight – check if the carbon brushes are properly installed and the carbon brush wick wire is not caught between the spring • Worn out ball bearing • Motor assembly screws (Picture 34) are not fully tightened or tightened unevenly – tighten the screws |

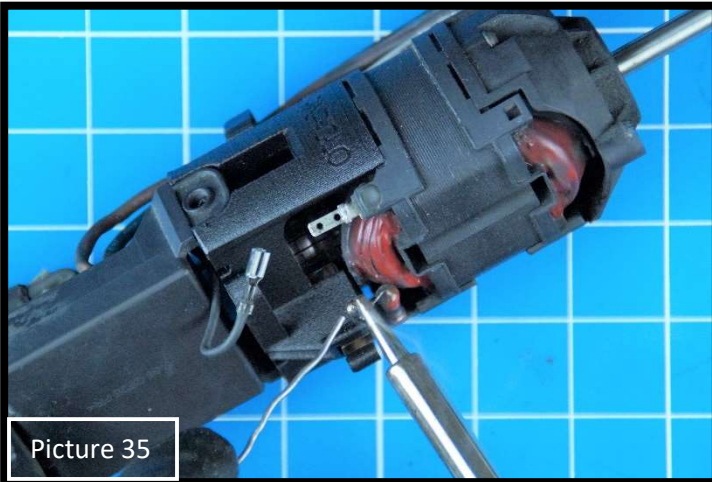
Solder the brush holder tab with the resistor leg.
Remember to do this on both sides!

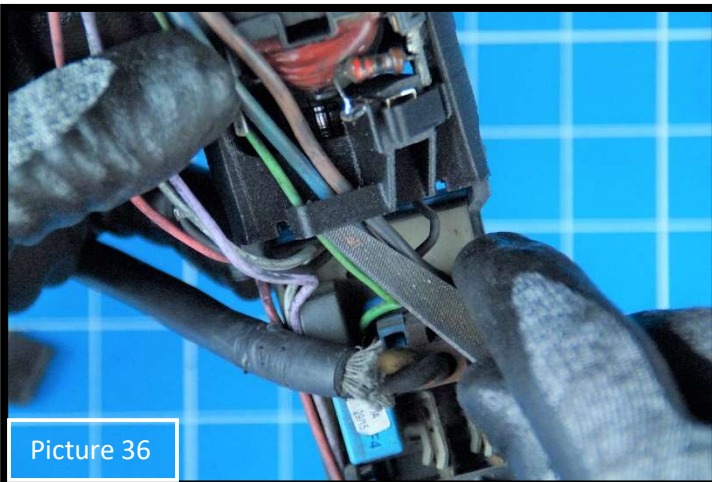
Slide back in the wires in the retaining bracket in the correct order:
brown – blue – green – grey – violet
- red

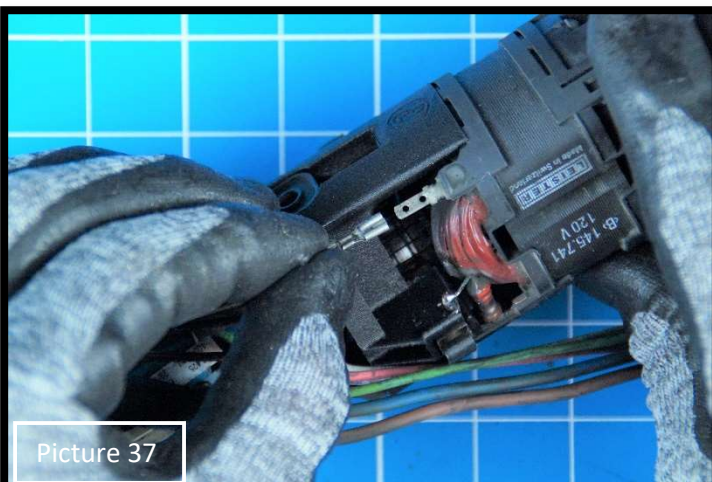
Connect both motor power cables.

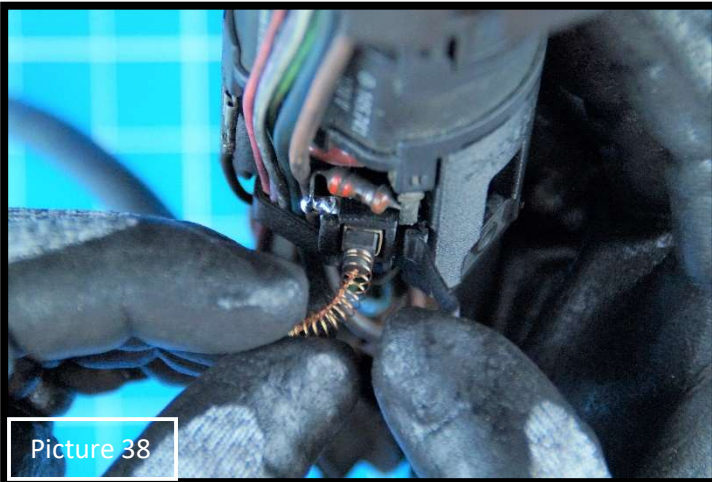
Picture 38

Gently pull back the brush retaining clip with one hand and with the other install new carbon brush.

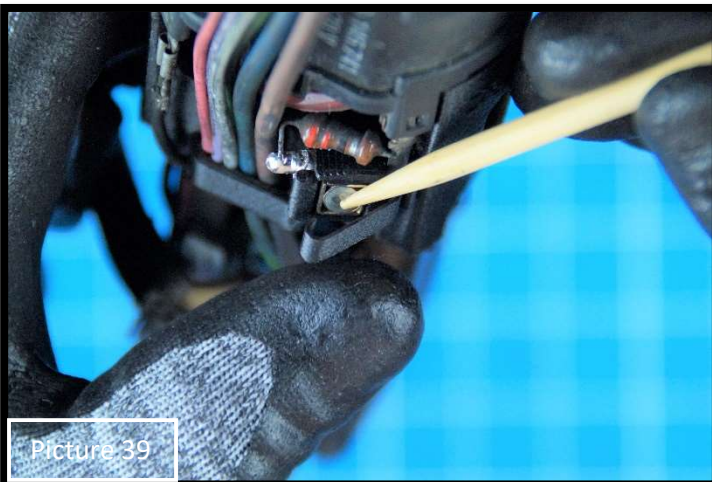
Picture 39

Compress the carbon brush spring using fingers and holding it with a thin tool and then close the retaining clip by pressing it to the brush holder body.

When compressing the carbon brush spring pay close attention to keep the shunt inside the spring perimeter.

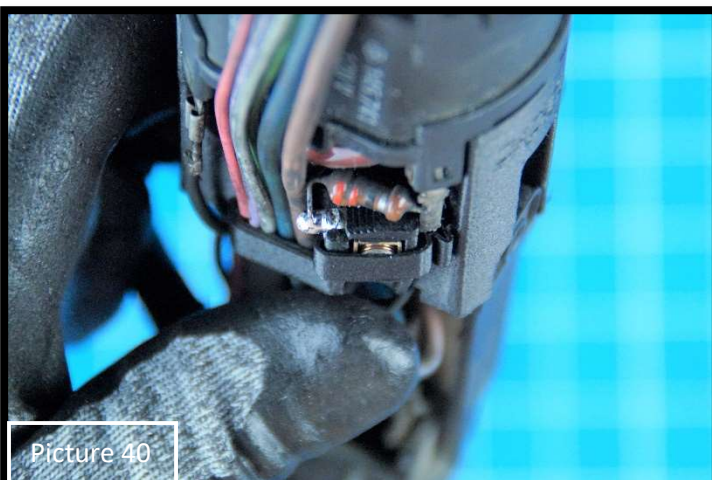
Picture 40

Properly closed retaining clip
